**GREENSFERRY OVERPASS**  
Early May 2015 – Girder Placement

## GREENSFERRY OVERPASS

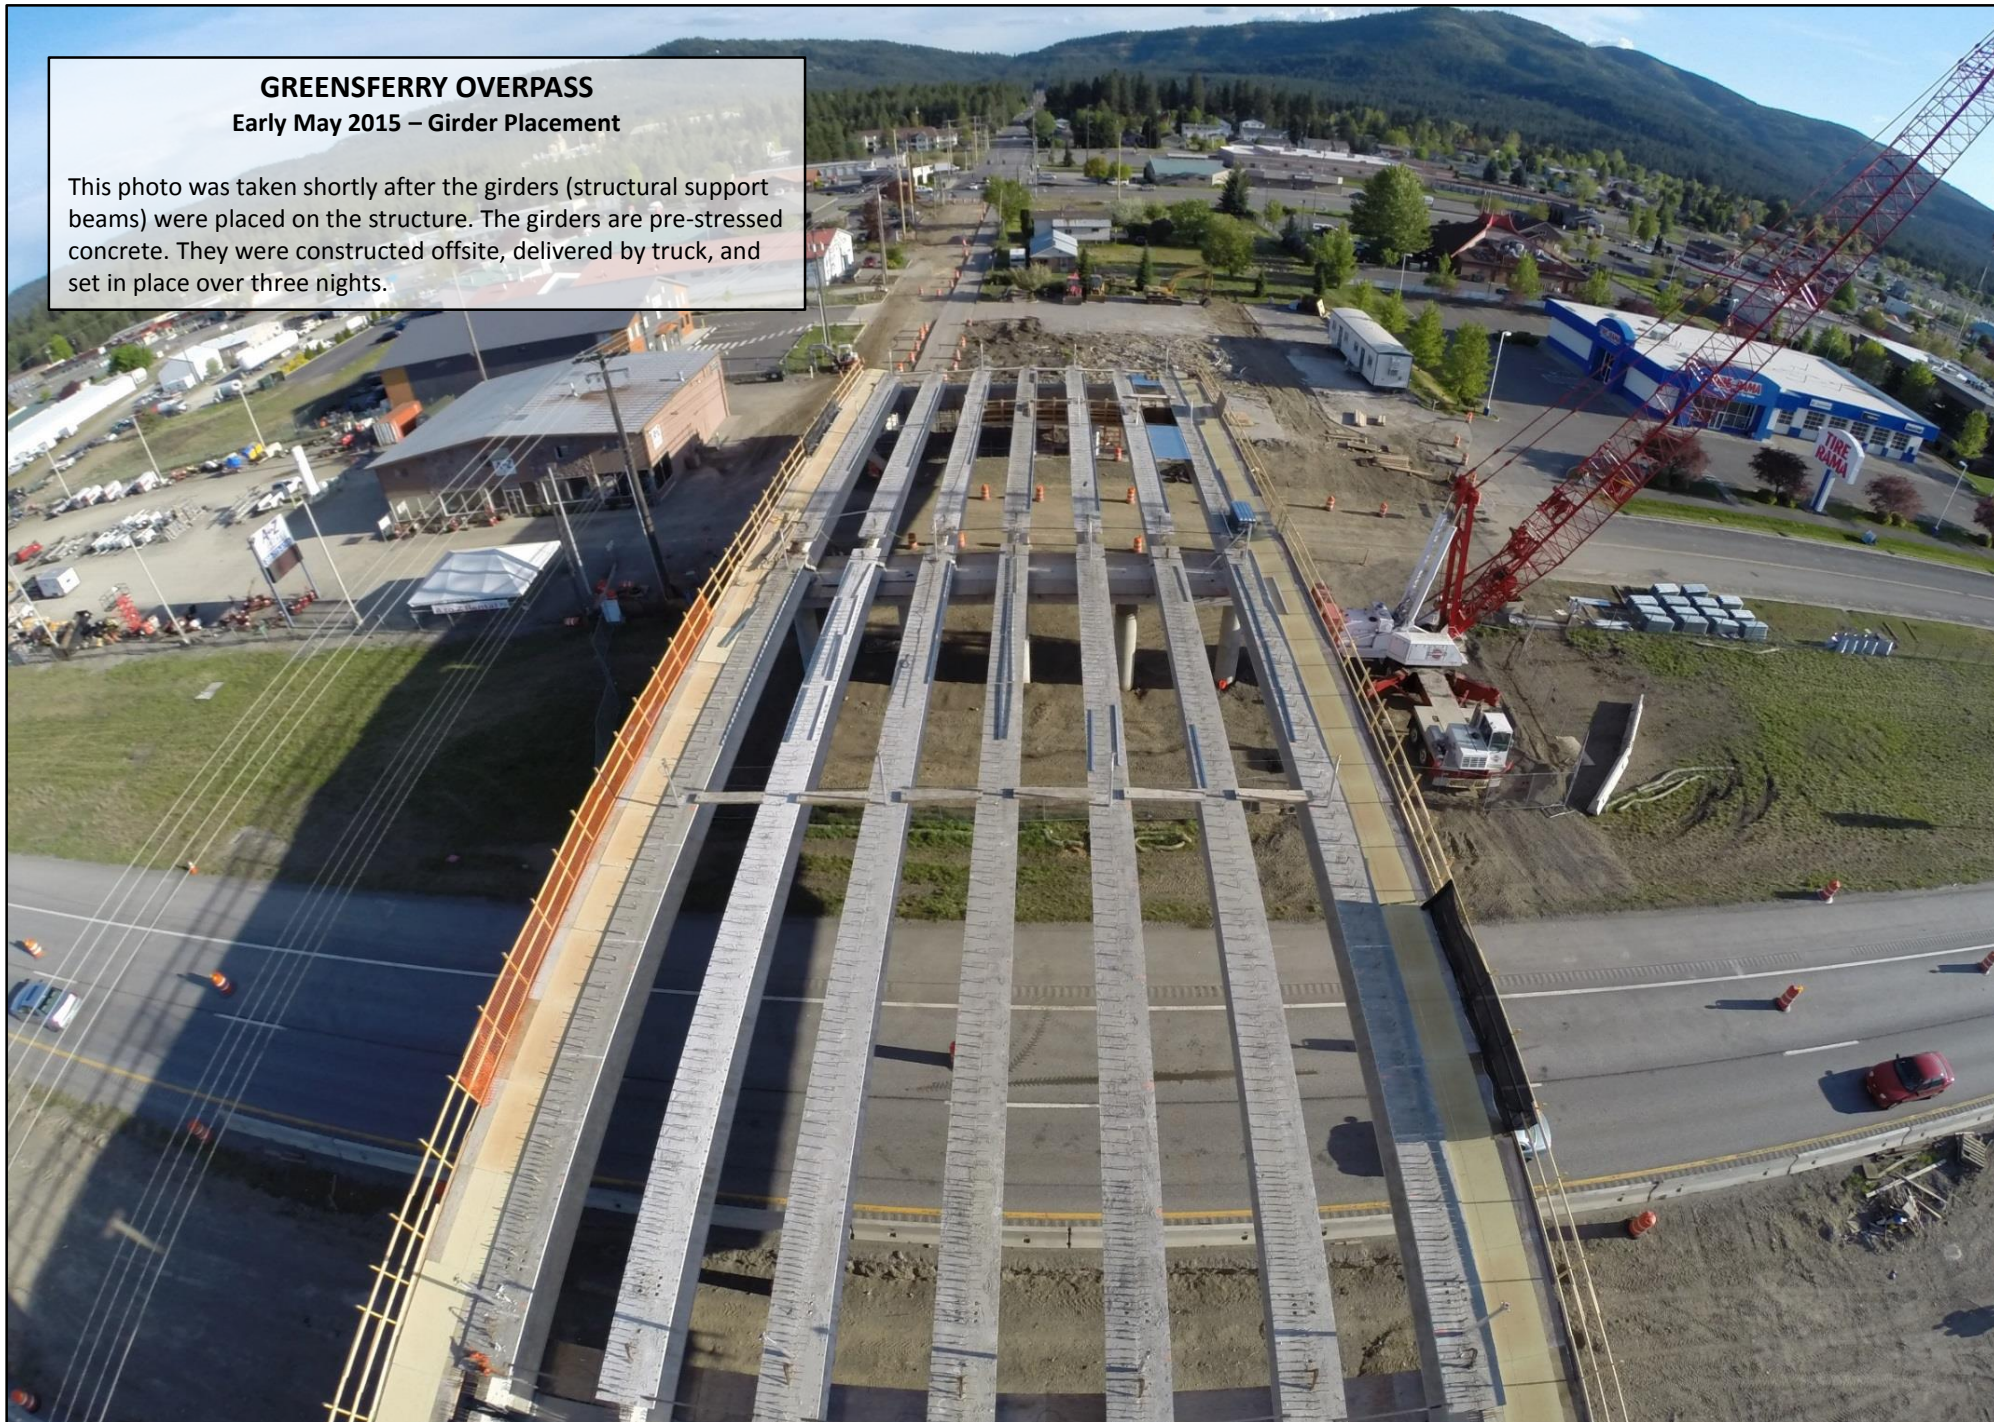
This photo was taken shortly after the girders (structural support beams) were placed on the structure. The girders are pre-stressed concrete. They were constructed offsite, delivered by truck, and set in place over three nights.

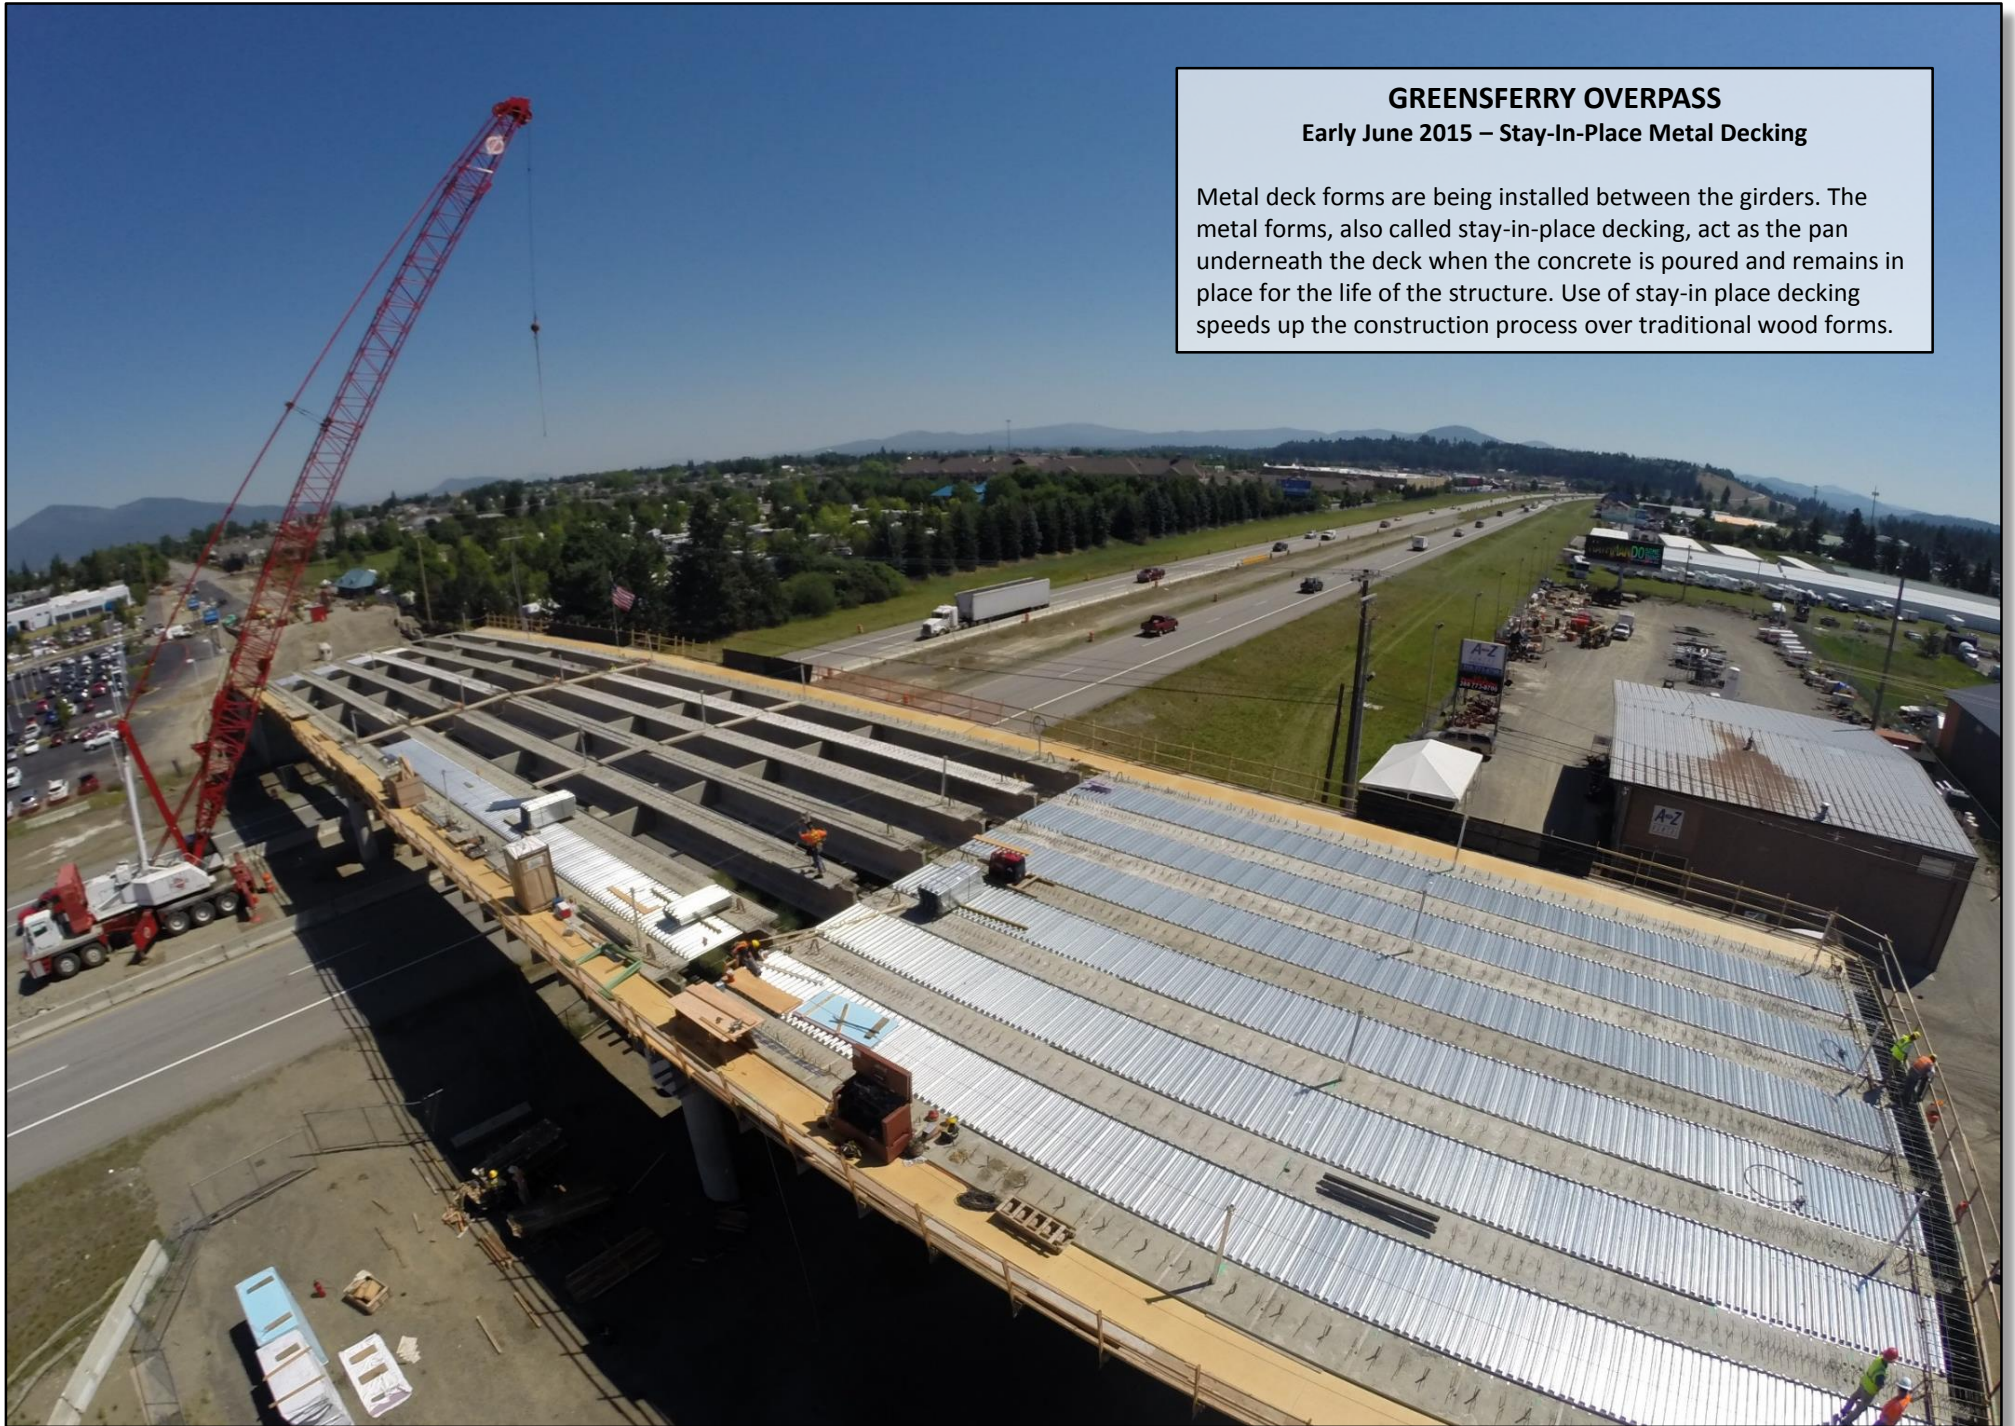
Early June 2015 – Stay-In-Place Metal Decking

Metal deck forms are being installed between the girders. The metal forms, also called stay-in-place decking, act as the pan underneath the deck when the concrete is poured and remains in place for the life of the structure. Use of stay-in place decking speeds up the construction process over traditional wood forms.

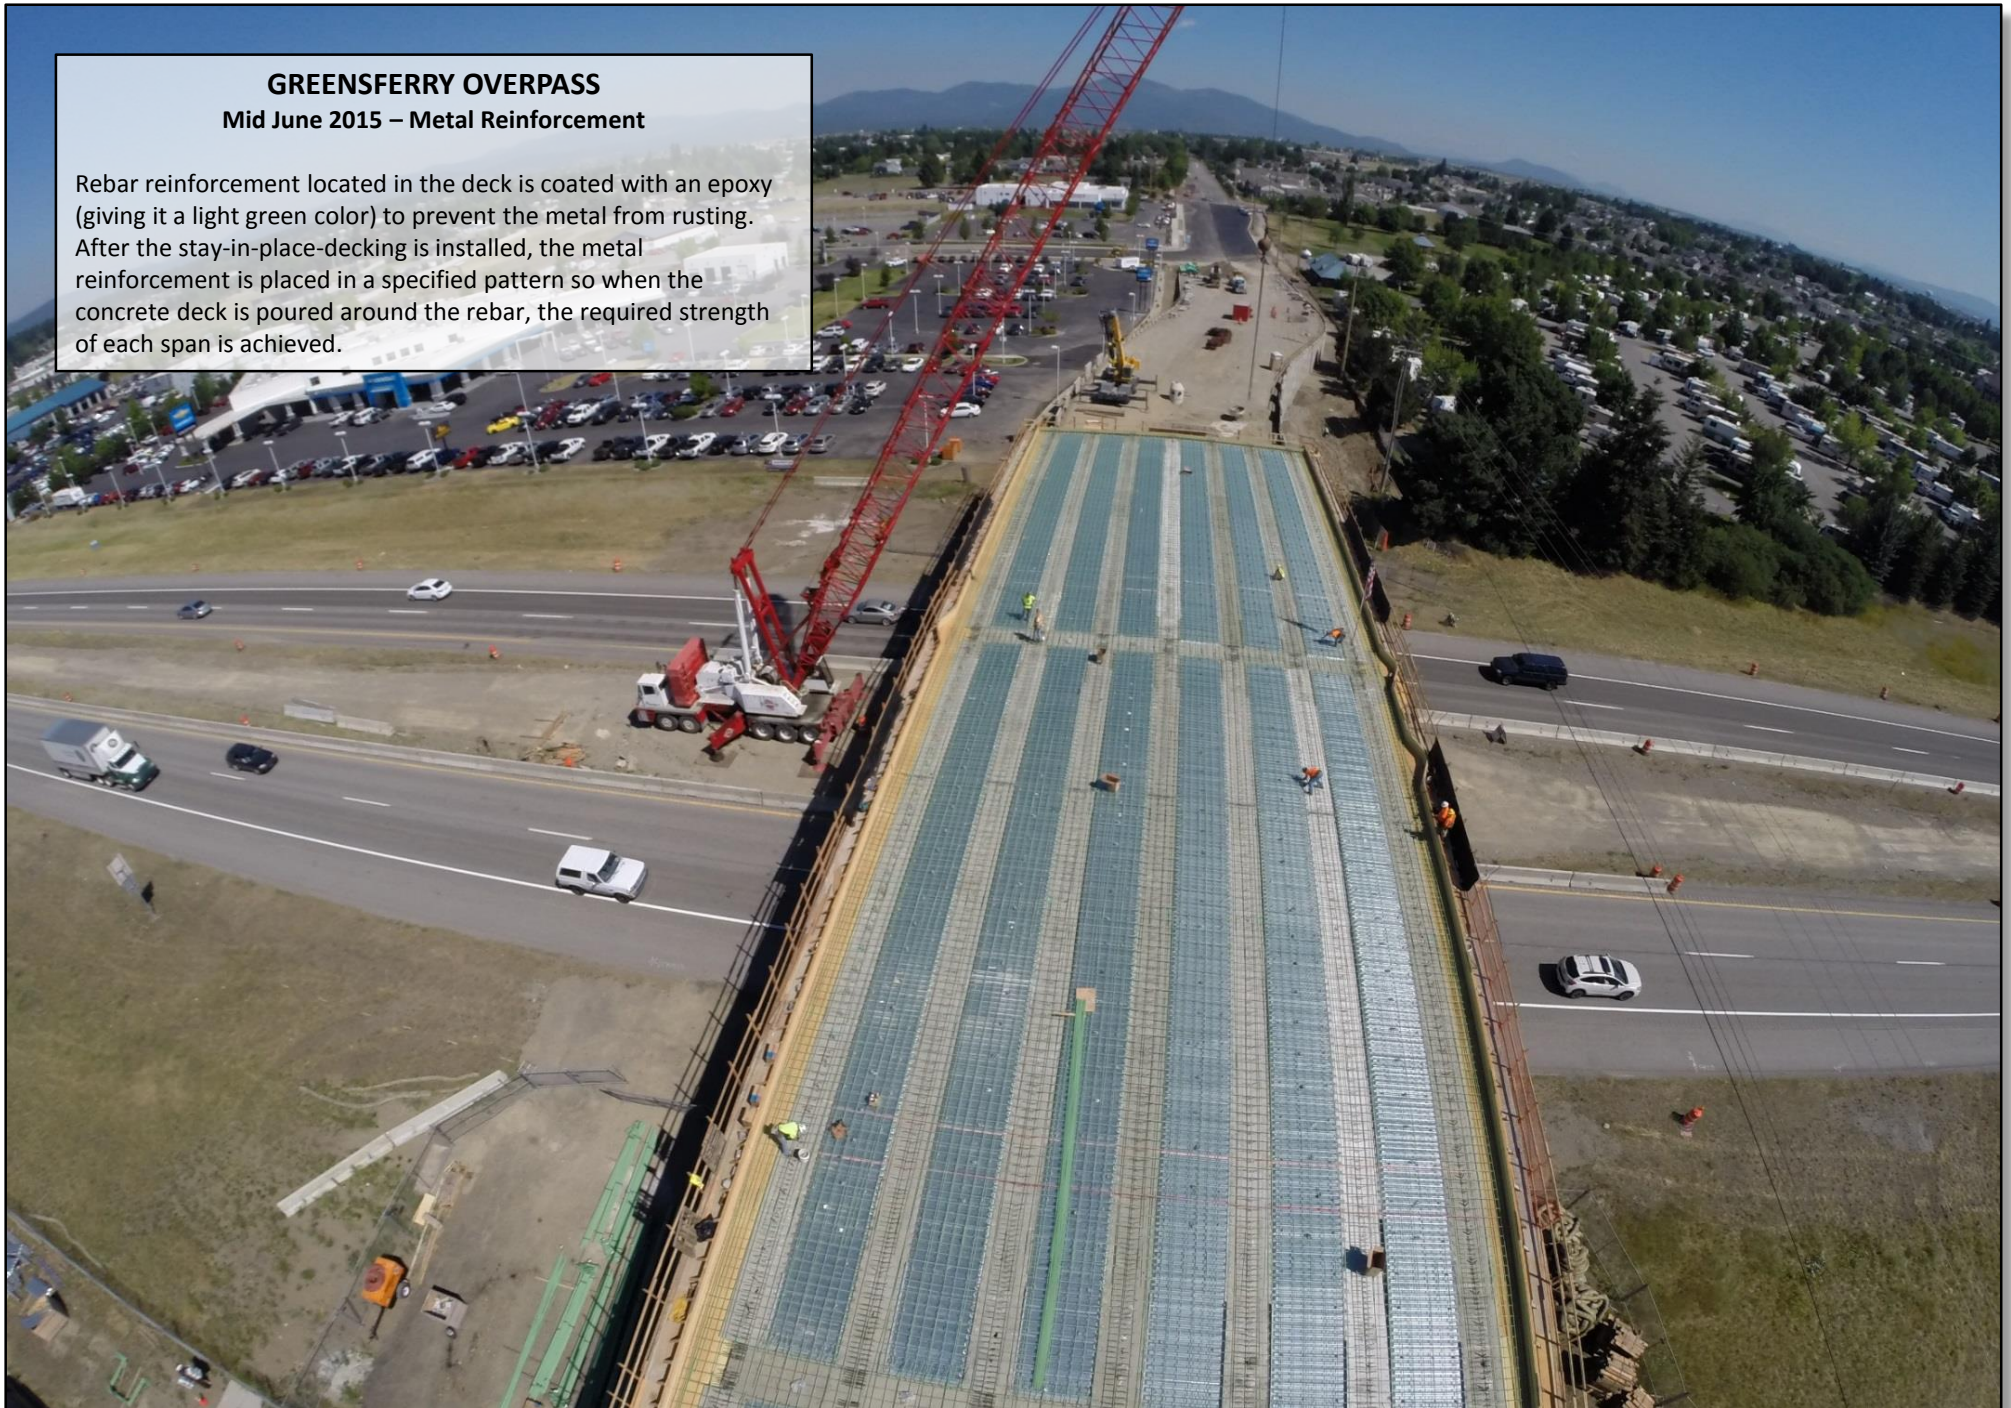
**Mid June 2015 – Metal Reinforcement**

Rebar reinforcement located in the deck is coated with an epoxy (giving it a light green color) to prevent the metal from rusting. After the stay-in-place-decking is installed, the metal reinforcement is placed in a specified pattern so when the concrete deck is poured around the rebar, the required strength of each span is achieved.

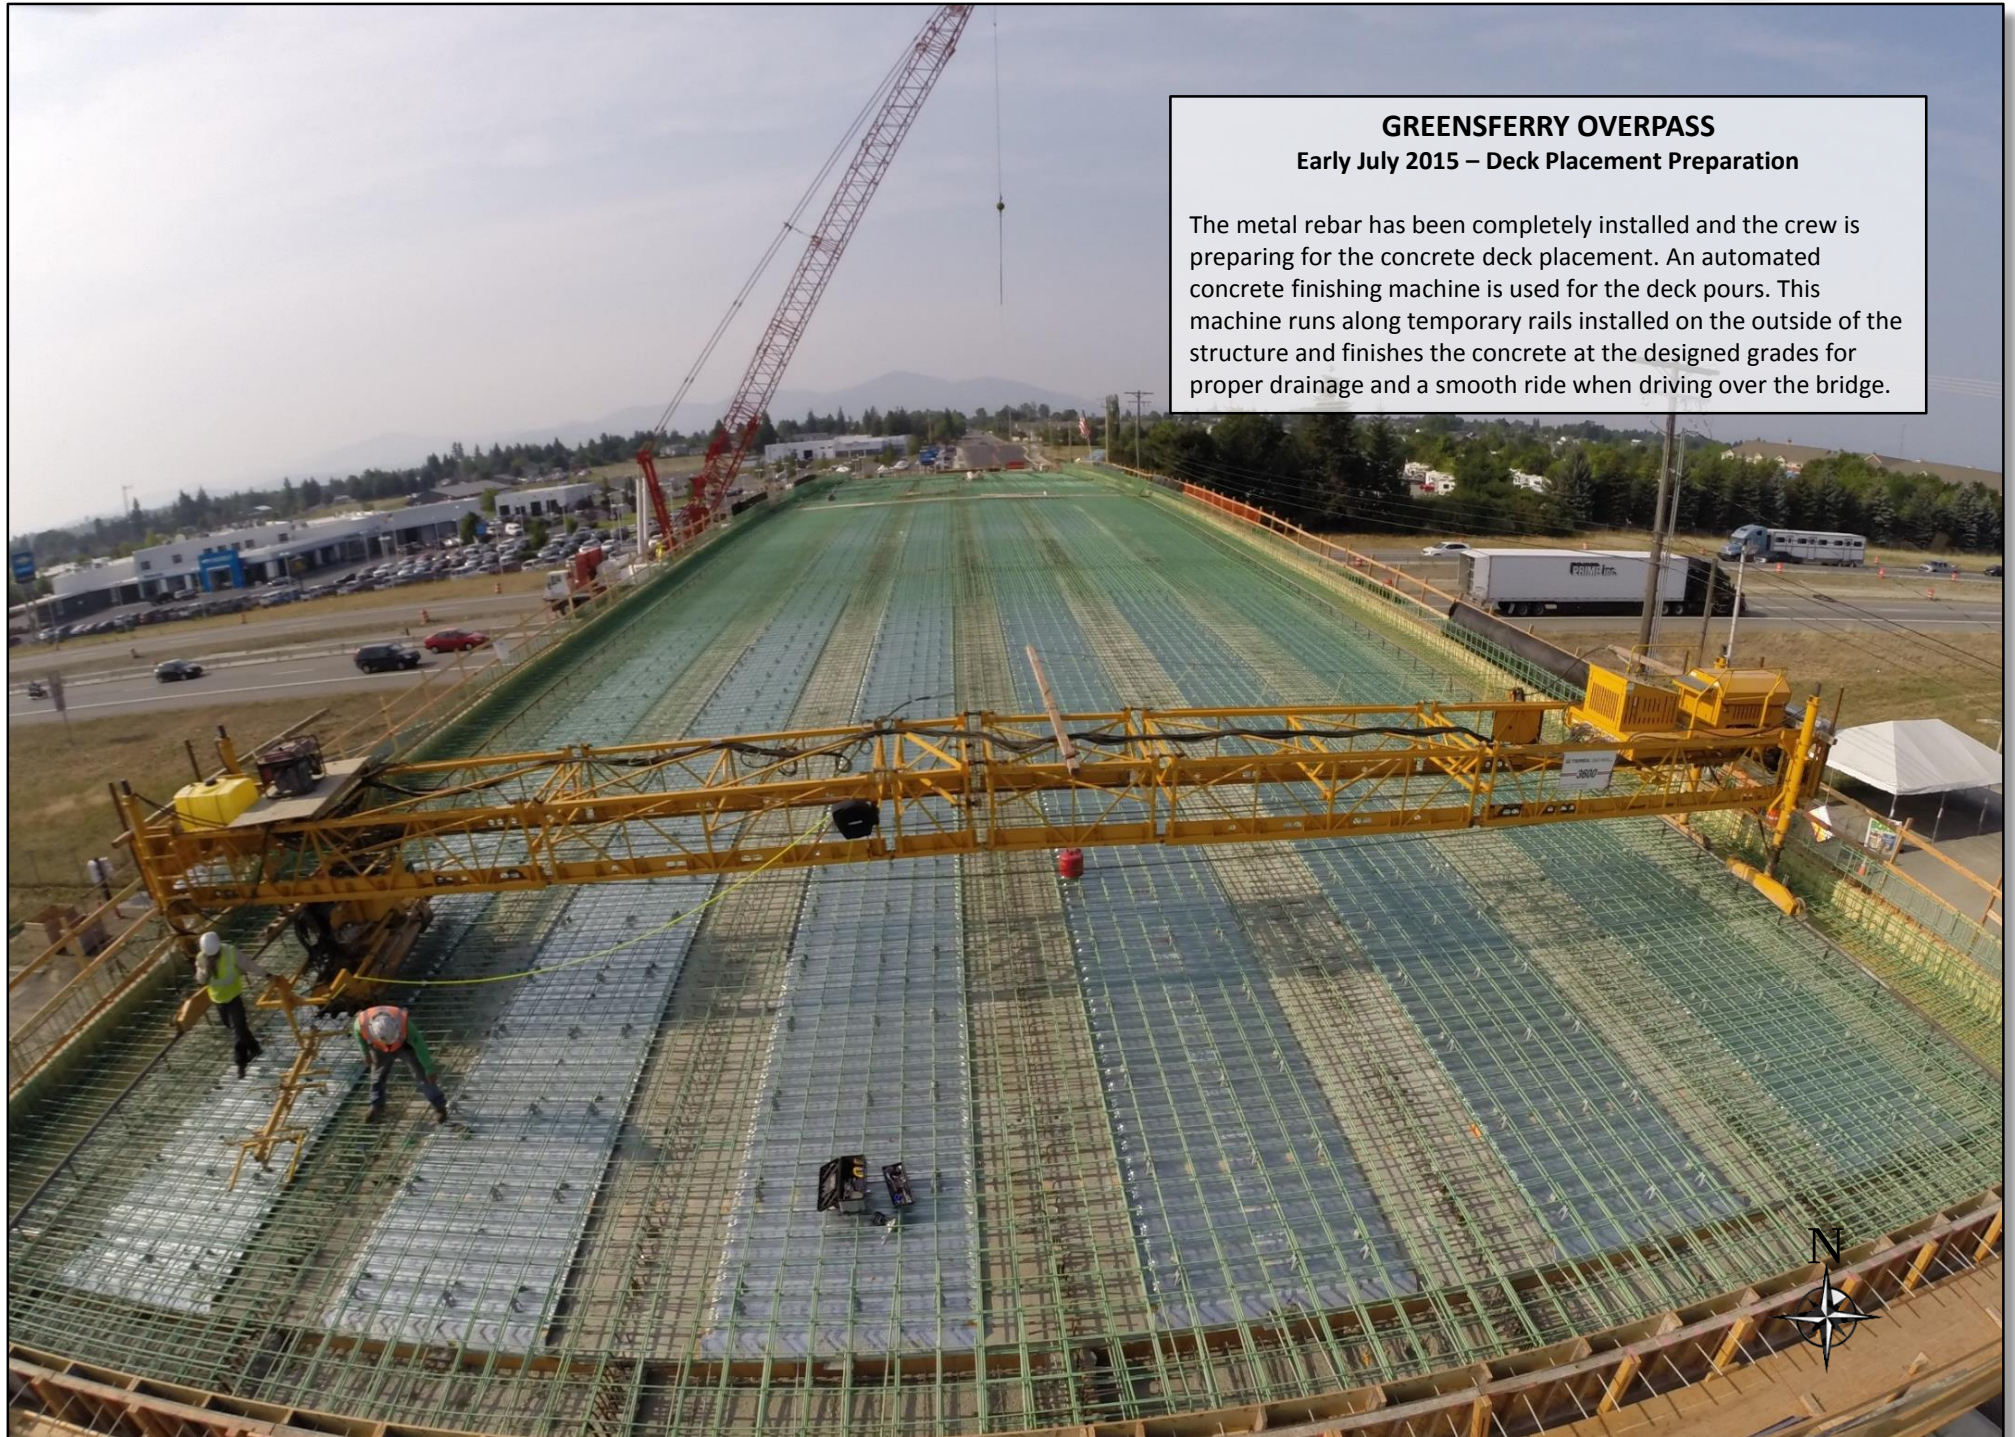
Early July 2015 – Deck Placement Preparation

The metal rebar has been completely installed and the crew is preparing for the concrete deck placement. An automated concrete finishing machine is used for the deck pours. This machine runs along temporary rails installed on the outside of the structure and finishes the concrete at the designed grades for proper drainage and a smooth ride when driving over the bridge.

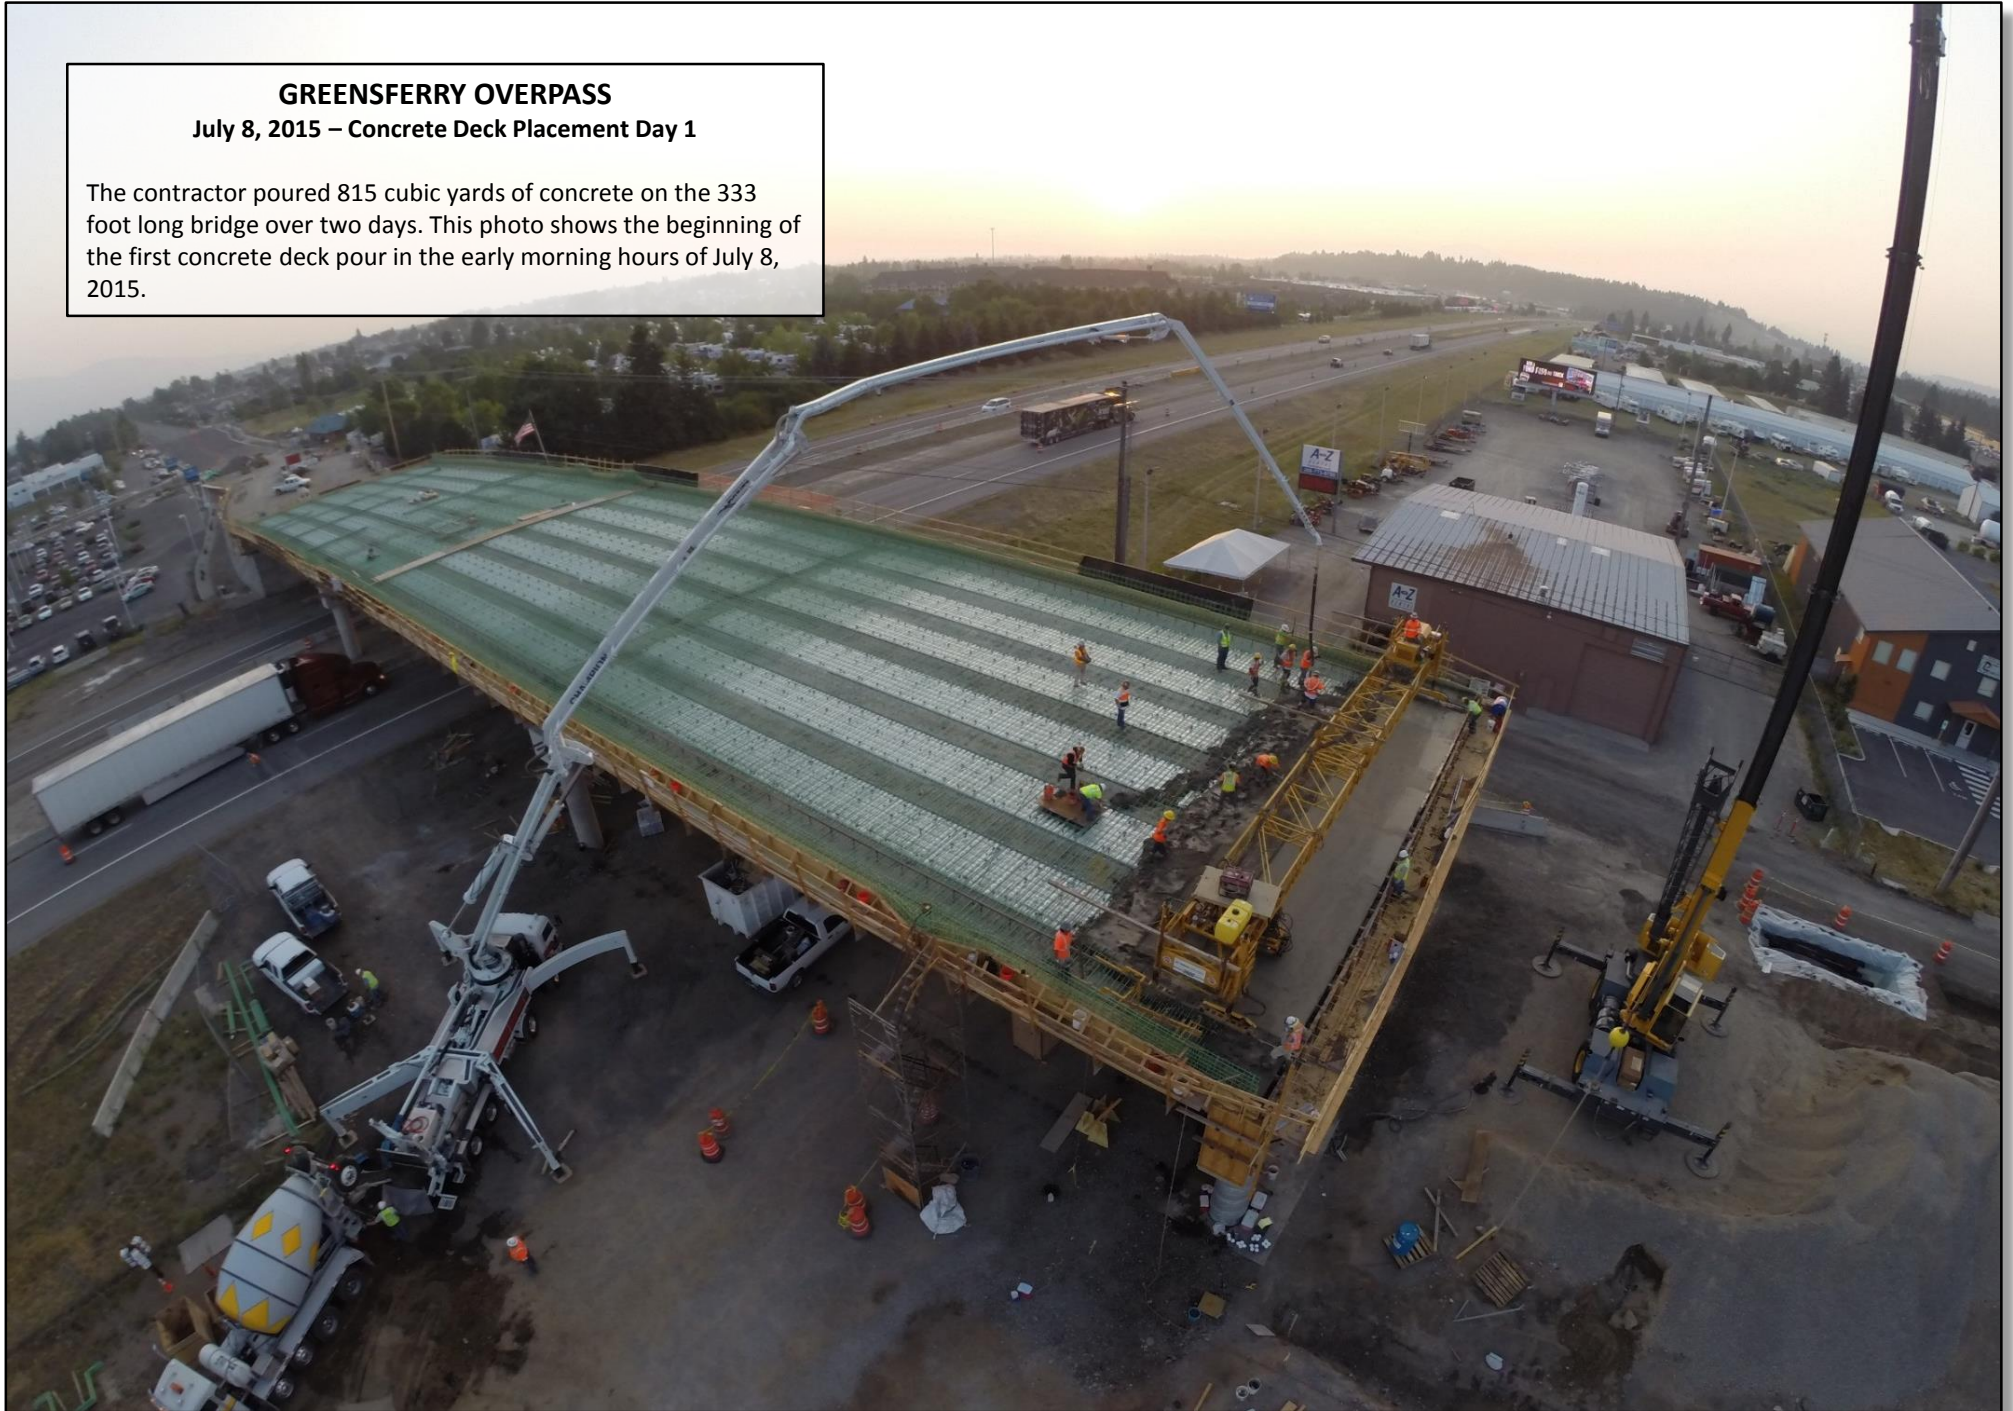
**July 8, 2015 – Concrete Deck Placement Day 1**

The contractor poured 815 cubic yards of concrete on the 333 foot long bridge over two days. This photo shows the beginning of the first concrete deck pour in the early morning hours of July 8, 2015.

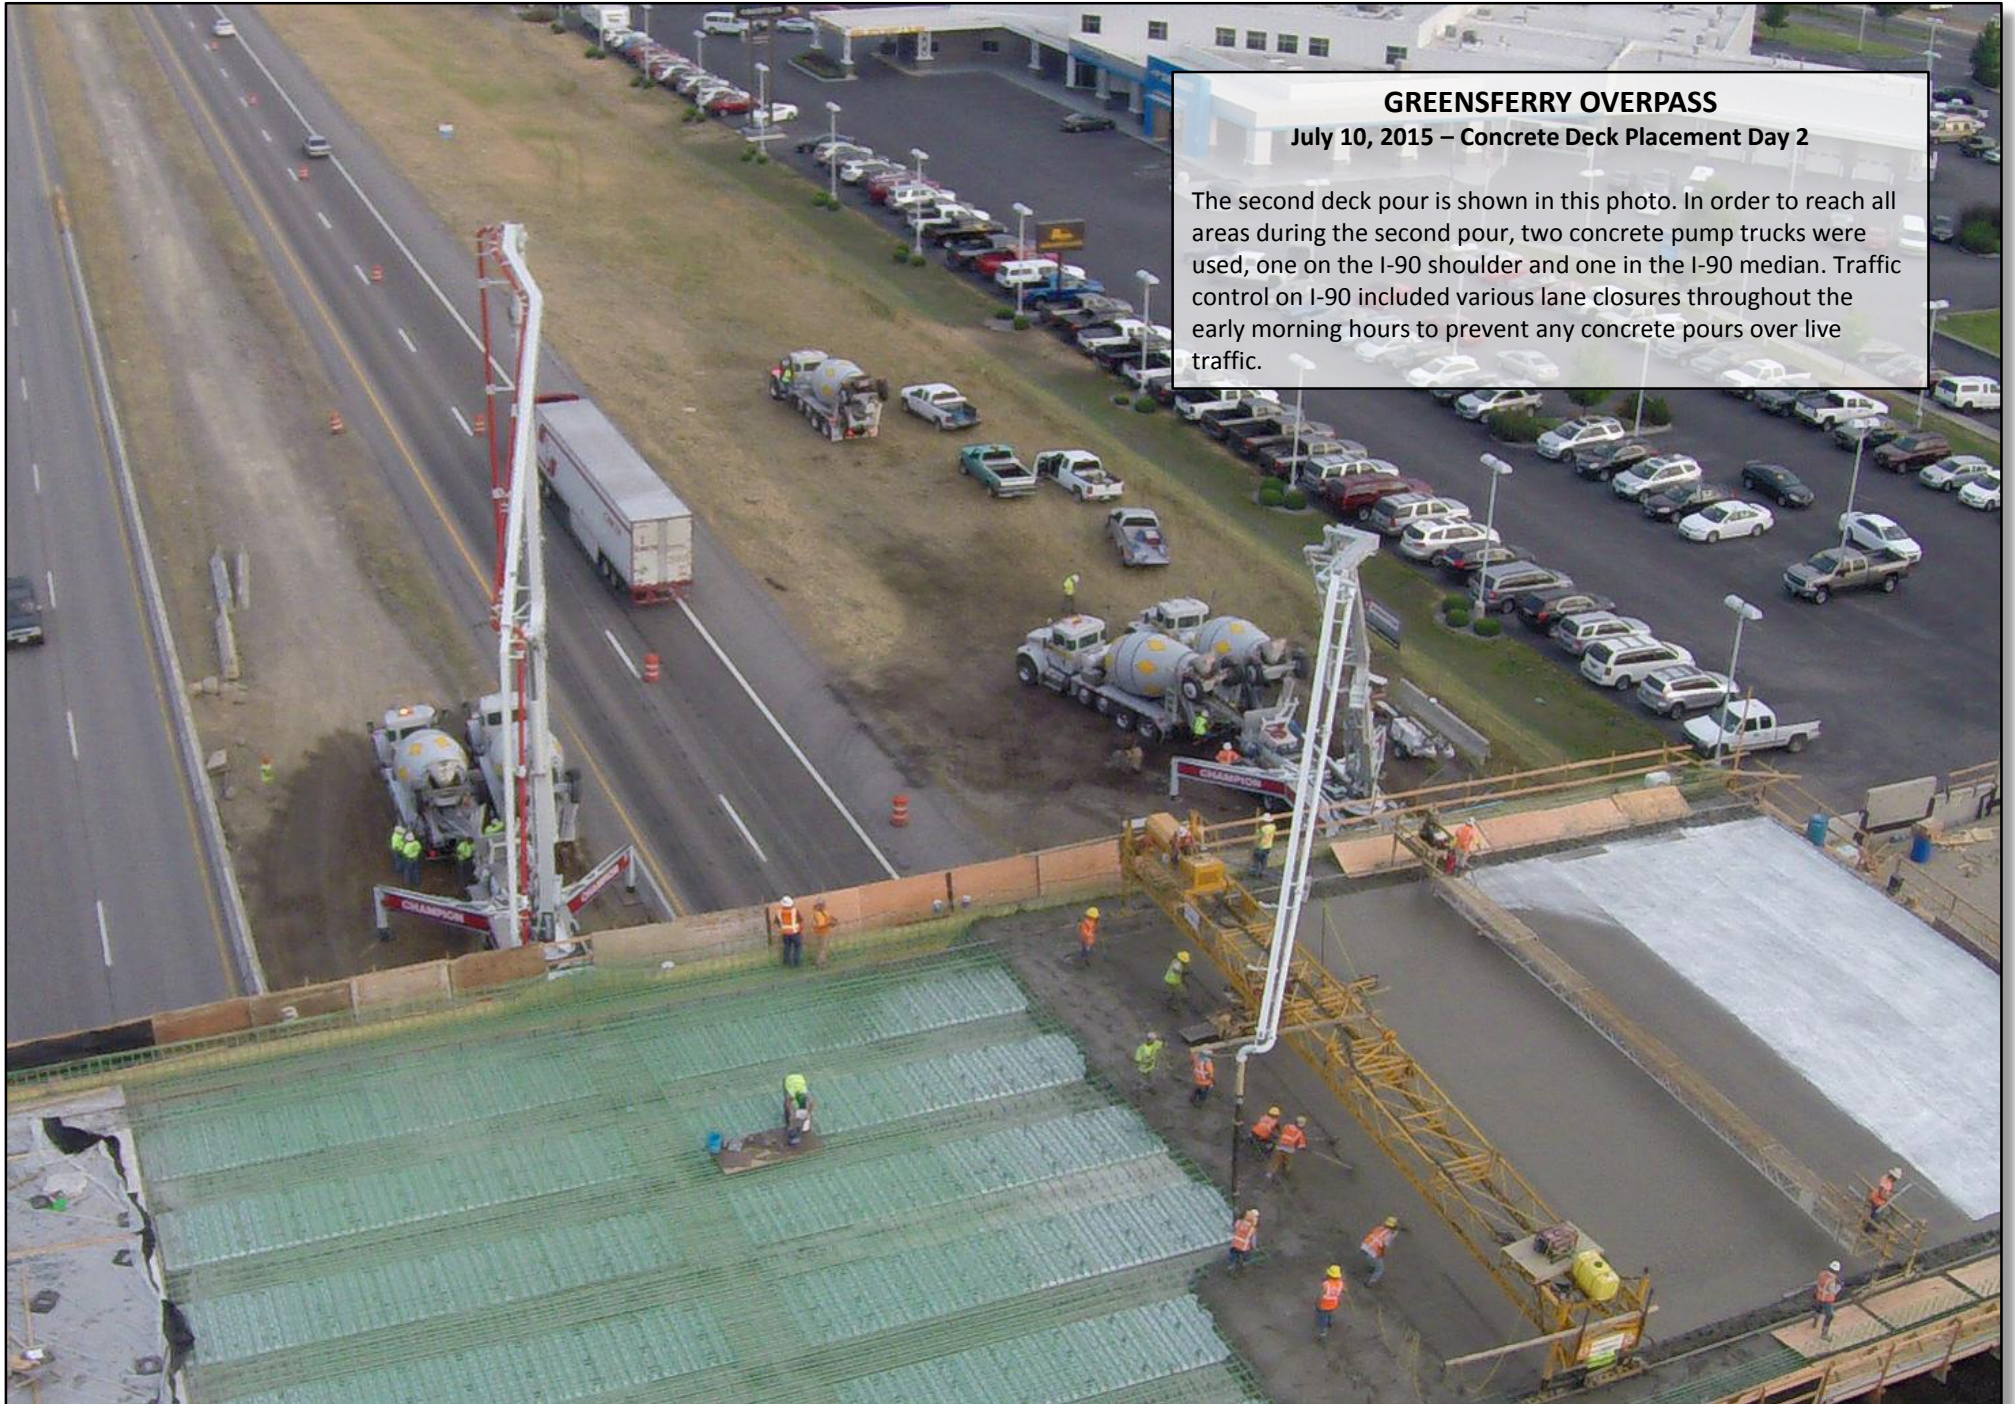
July 10, 2015 – Concrete Deck Placement Day 2

The second deck pour is shown in this photo. In order to reach all areas during the second pour, two concrete pump trucks were used, one on the I-90 shoulder and one in the I-90 median. Traffic control on I-90 included various lane closures throughout the early morning hours to prevent any concrete pours over live traffic.

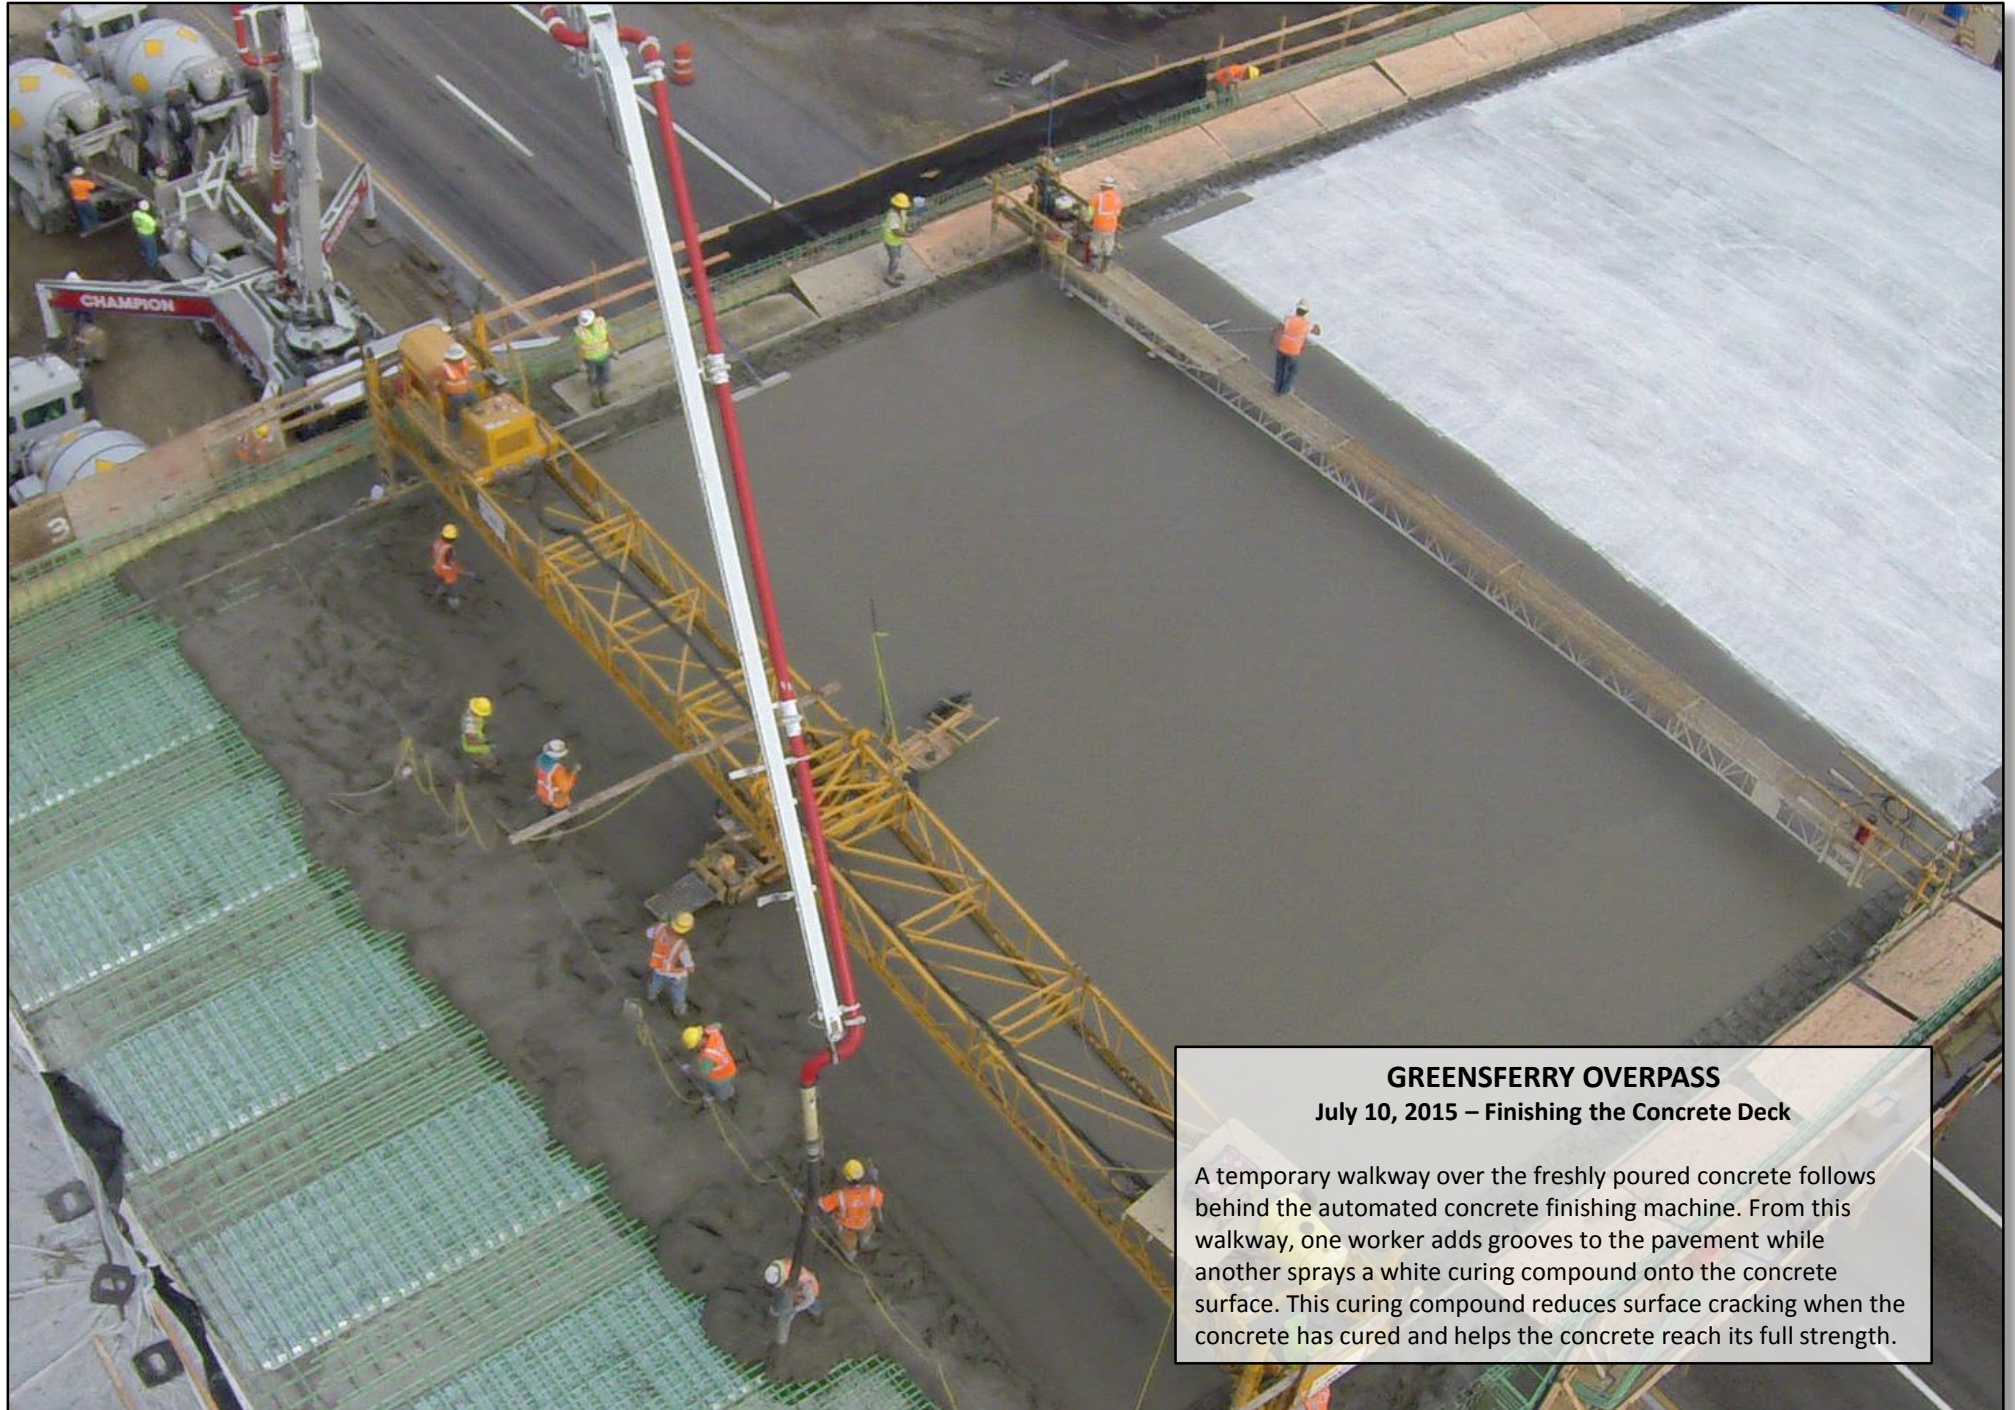
July 10, 2015 – Finishing the Concrete Deck

A temporary walkway over the freshly poured concrete follows behind the automated concrete finishing machine. From this walkway, one worker adds grooves to the pavement while another sprays a white curing compound onto the concrete surface. This curing compound reduces surface cracking when the concrete has cured and helps the concrete reach its full strength.
