**GREENSFERRY OVERPASS**  
Early May 2015 – Girder Placement

## GREENSFERRY OVERPASS

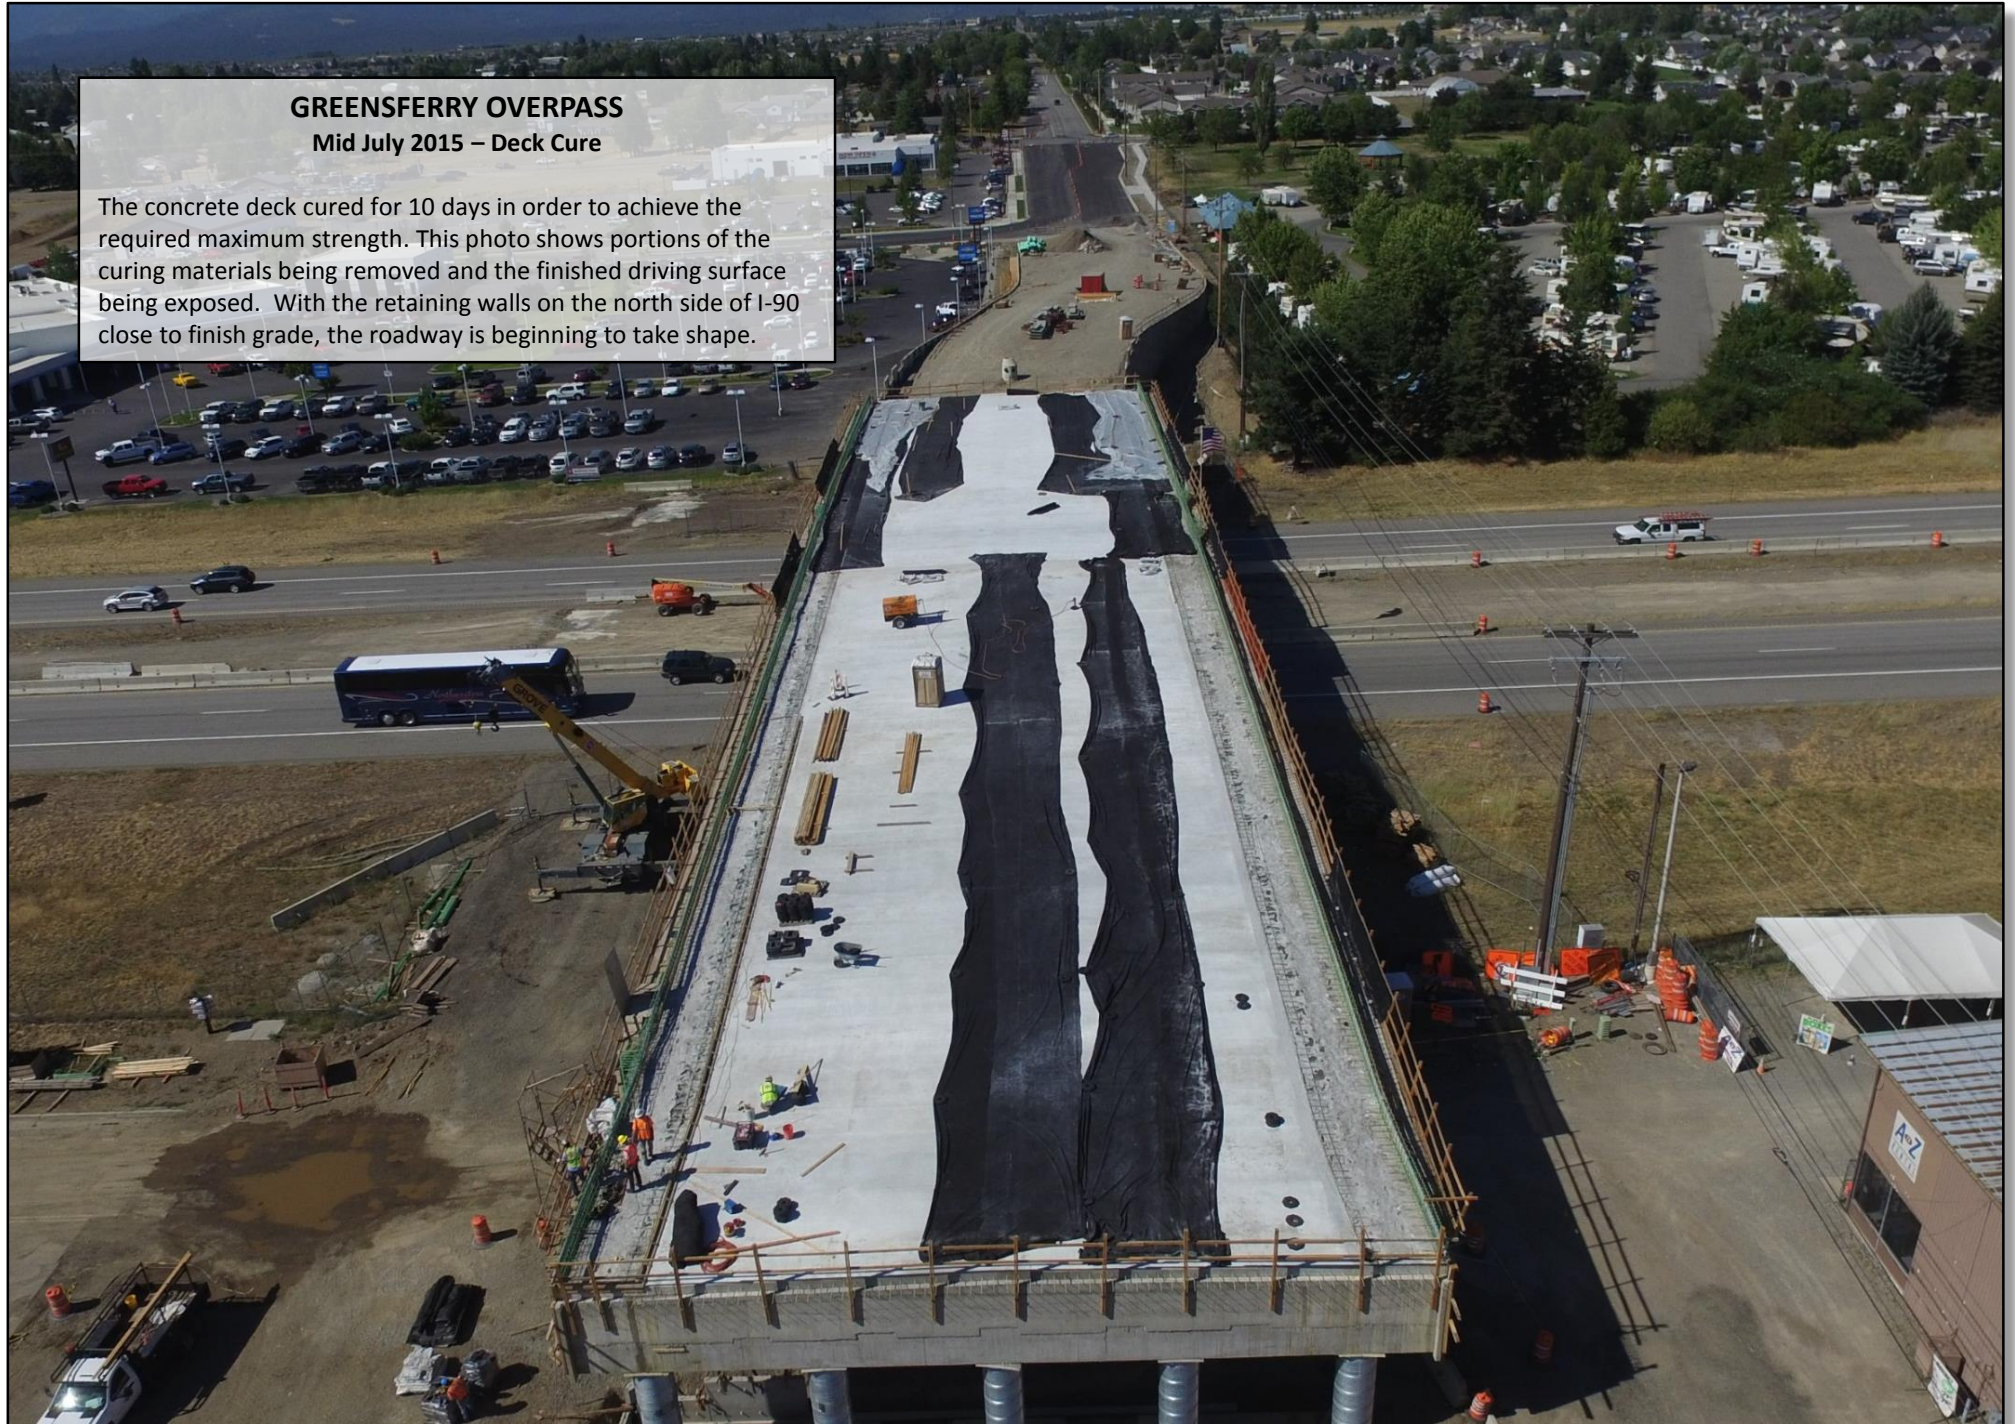
**Mid July 2015 – Deck Cure**

The concrete deck cured for 10 days in order to achieve the required maximum strength. This photo shows portions of the curing materials being removed and the finished driving surface being exposed. With the retaining walls on the north side of I-90 close to finish grade, the roadway is beginning to take shape.
